Fire and Safety Department Report

To: LFB/Fire Investigation Team - Dowgate

Examination of Cladding Panels – Flat 28 Shepherds Court, 21 Shepherd's Bush Green, W12.

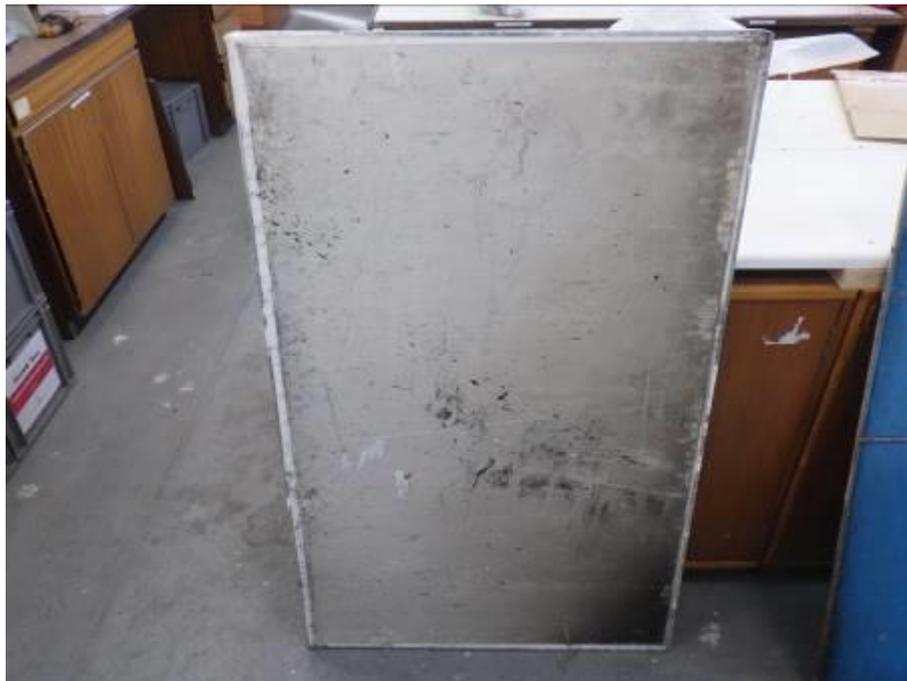
- 2.11 The second (complete) panel had suffered slight superficial fire damage on the front face from falling fire debris, but was otherwise intact.
- 2.12 The front surface of the complete panel was a metal sheet approximately 1mm in thickness; the metal sheet attracted a magnet and was therefore presumed to be steel.

Photograph 2: Front (external) face of the complete panel.

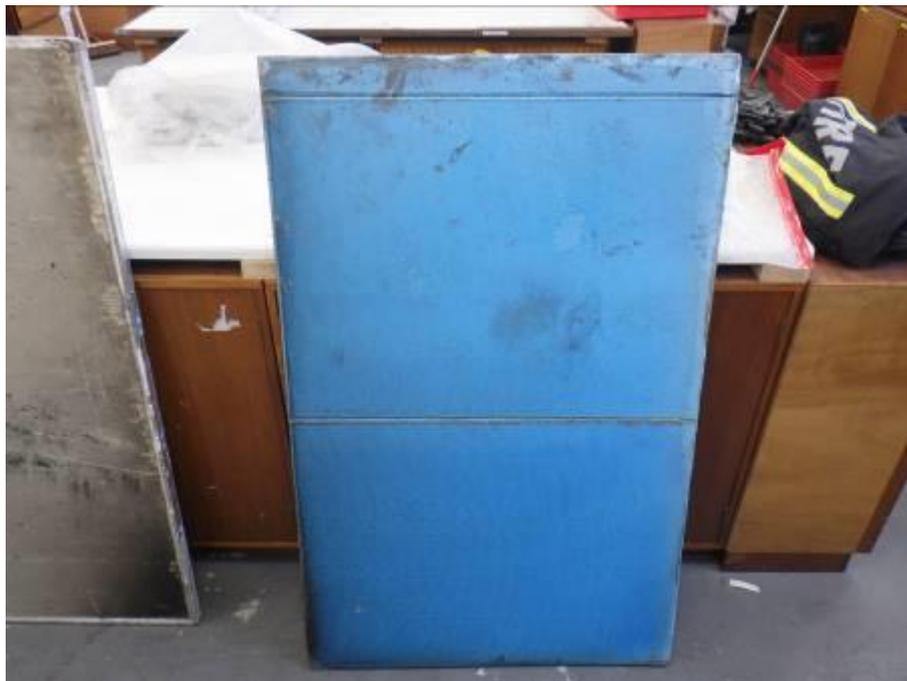
- 2.5 The first panel was incomplete as the external surface had come away during the fire, exposing blue plastic foam underneath.
- 2.6 The blue plastic foam was mounted on a plywood board, the thickness of which varied across the width of the panel (approximately in the range 17-23mm).

- 2.7 The blue foam had melted in some places, and had been blackened in others, particularly along the lowest edge of the panel.
- 2.8 The melting of the blue foam had exposed the plywood layer of the panel, particularly along the lowest edge of the panel.

Photograph 3: Front face of the damaged panel.

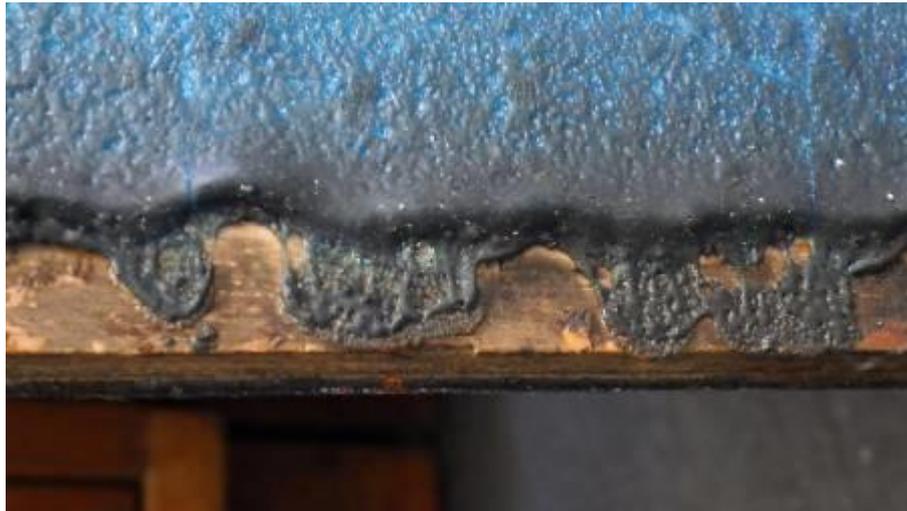
Photograph 6: Close up of fire damage to the blue plastic foam layer, exposing plywood layer underneath.

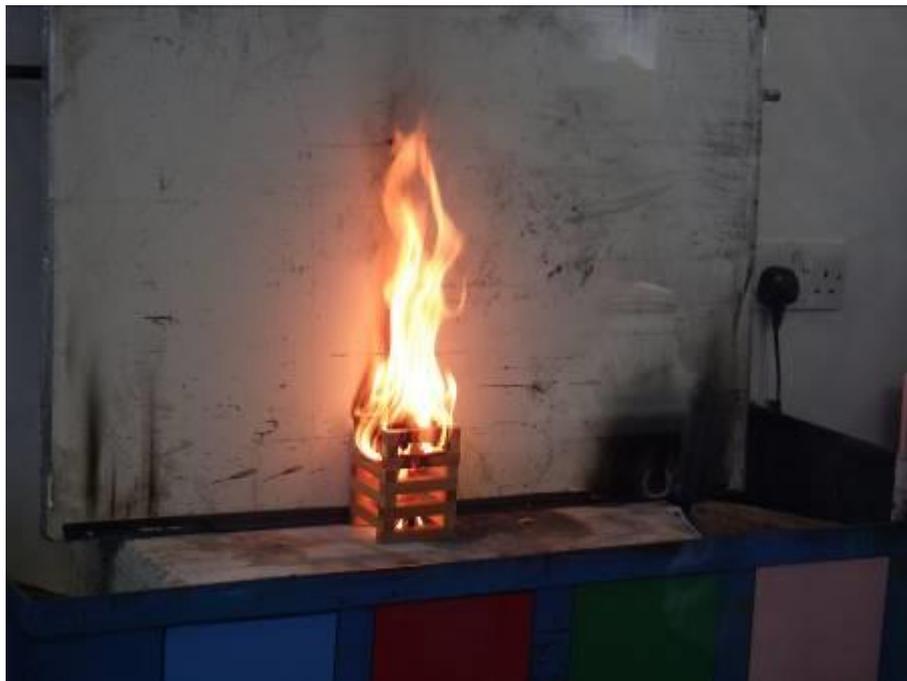
- 3.3 The flame tests all inflicted negligible fire damage to the metal surface of the complete panel. Removal of the external steel sheet showed that the blue foam layer underneath the steel sheet at the location of the flame tests had melted away. In the ‘Crib 6’ flame test, the blue foam had also been completely destroyed in some areas exposing the plywood underneath.

Photograph 9: ‘Crib 6’ test on the complete panel.

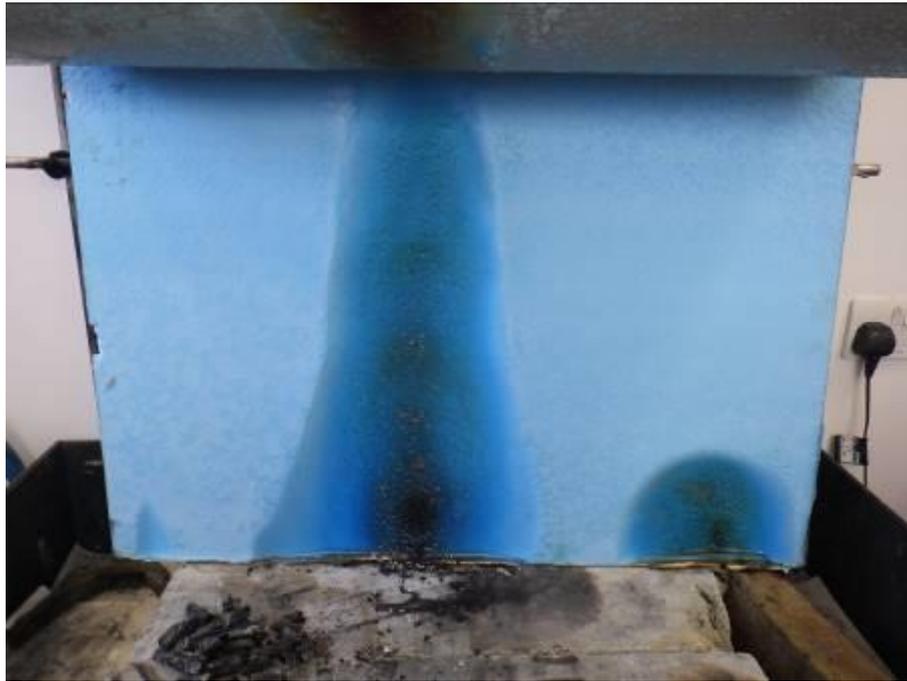
- 2.18 The tests were conducted for 1 minute on the complete panel, with the exception of the ‘Crib 6’ test, which was run for 10 minutes in total.
- 2.19 None of the flame tests penetrated the steel sheet, however, removal of the steel sheet revealed varying degrees of fire damage to the blue foam layer underneath.

Photograph 10: Complete panel after the 3 flame tests with front steel sheet removed.

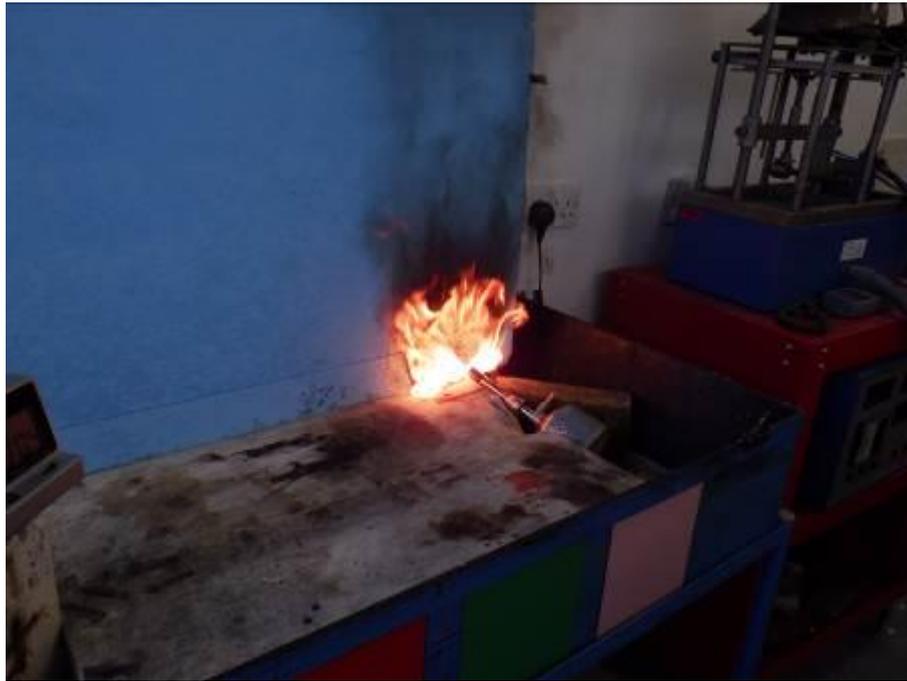
- 2.23 The repeat series of flame tests resulted in greater flame heights than the initial series of tests.
- 2.24 Flaming droplets were formed during the repeat flame tests that involved the blowtorch and the ‘Crib 6’ ignition sources.
- 2.25 There was sustained burning of the panel after the removal the ignition source during both the blowtorch and the ‘Crib 6’ repeat flame tests.
- 2.26 The repeat ‘Crib 6’ flame test was stopped due concerns over the flame height.

- 3.5 The repeat flame tests, with the ignition sources placed directly against the blue foam layer, behaved as per the previous tests, except the destruction of the foam layer was significantly accelerated, and the flame heights generated were significantly higher than the first series of tests. The production of flaming droplets in the final test (‘Crib 6’ ignition source) was much more noticeable than with earlier tests.

Photograph 12: Repeat of the ‘Large flame’ test against the blue foam layer.

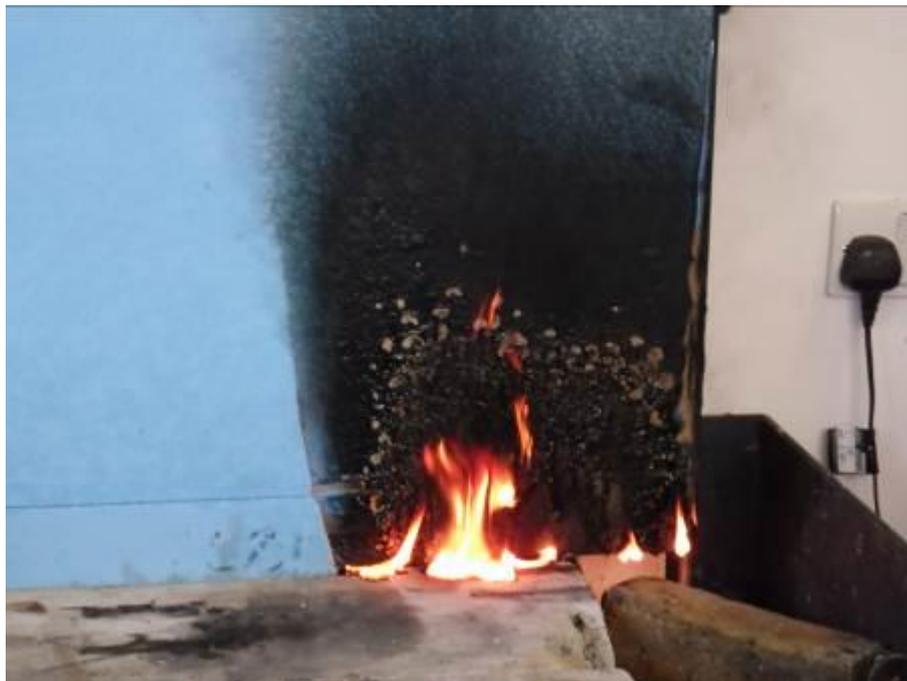
Photograph 13: After the ‘Large flame’ source had been withdrawn.

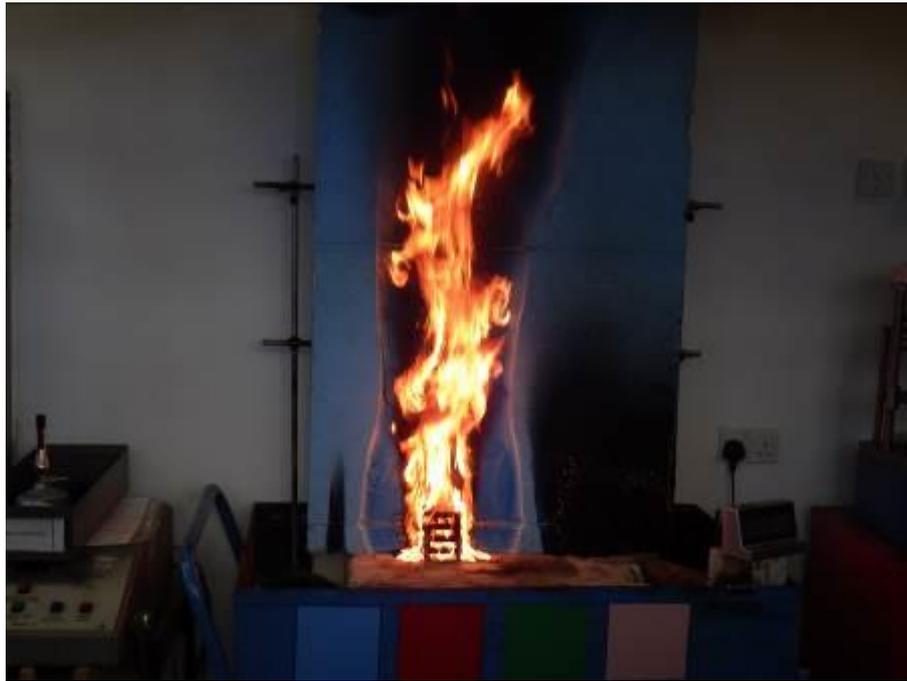
Photograph 14: Repeat of the ‘Crib 6’ test against the blue foam layer.
