Fire and Safety Department Report

To: LFB/Fire Investigation Team - Dowgate

Examination of Cladding Panels – Flat 28 Shepherds Court, 21 Shepherd's Bush Green, W12.

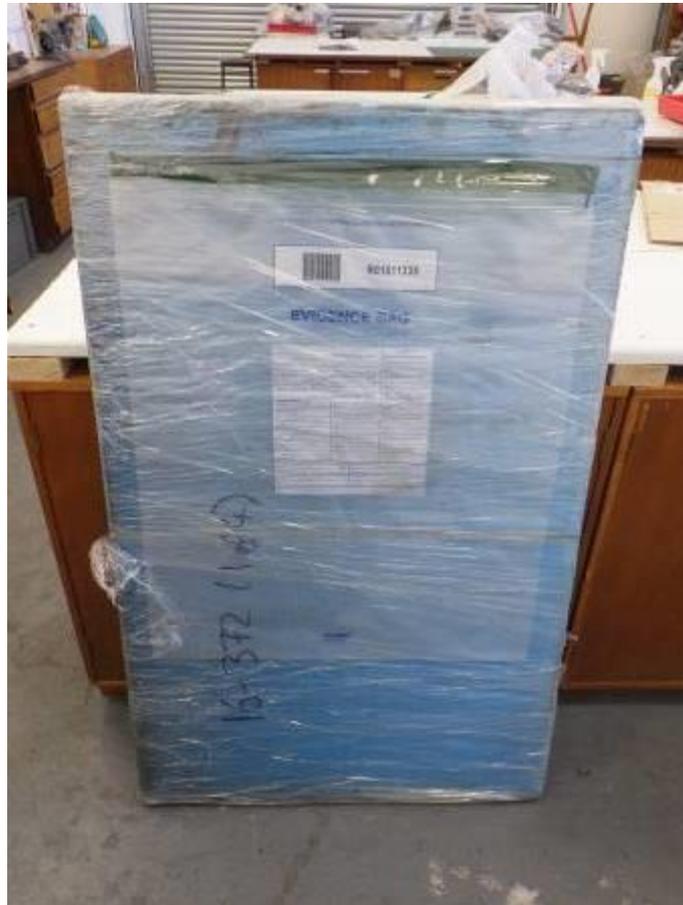
- 2.1 The sample received from the fire scene was 2 separate external cladding panels, measuring approximately 80cm by 127cm.
- 2.2 The first panel (incomplete) was sampled from outside the living room flat 58, on the 12th floor.
- 2.3 The second panel (complete) was sampled from outside the living room of the flat of fire origin (flat 28, 7th floor).
- 2.4 It was not known at the time of examination how long the panels had been fitted at the scene.

Photograph 1: Sample as received from the fire scene.

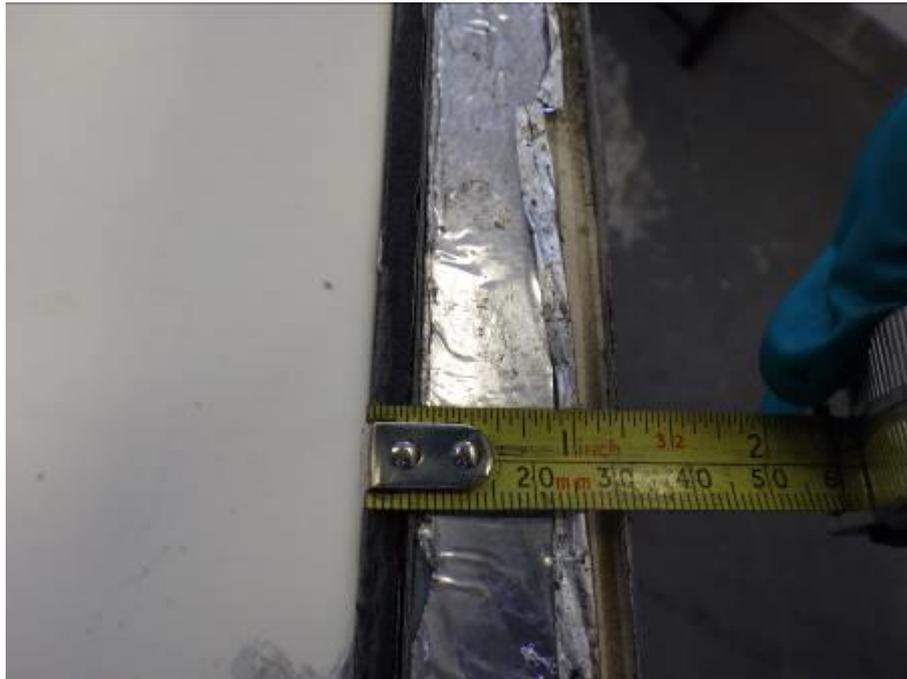
- 2.13 The steel sheet was finished with a white decorative paint.
- 2.14 The complete panel (all layers together) was a thickness of approximately 31mm.

Photograph 4: Thickness of the complete panel (31 mm).

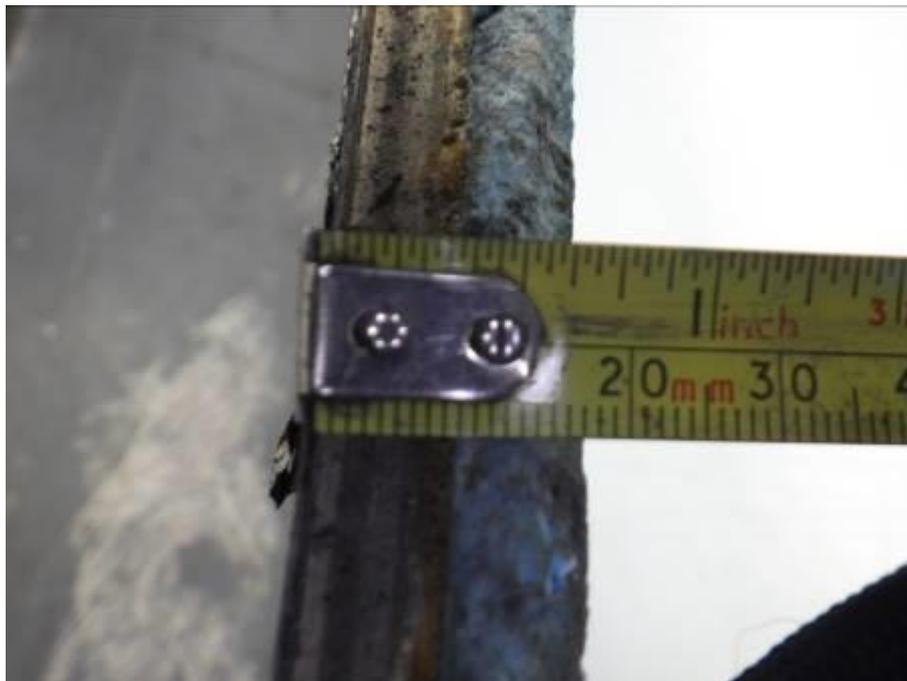
- 2.5 The first panel was incomplete as the external surface had come away during the fire, exposing blue plastic foam underneath.
- 2.6 The blue plastic foam was mounted on a plywood board, the thickness of which varied across the width of the panel (approximately in the range 17-23mm).

Photograph 5: Thickness of damaged panel (17mm pictured – although varied from 17-23mm across the width of the panel)

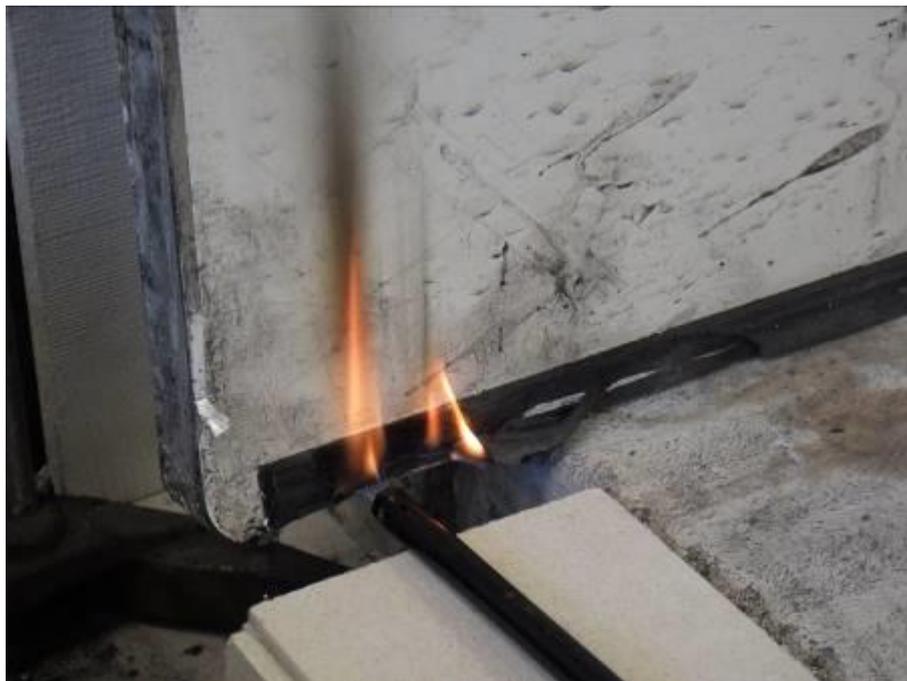
- 2.18 The tests were conducted for 1 minute on the complete panel, with the exception of the ‘Crib 6’ test, which was run for 10 minutes in total.
- 2.19 None of the flame tests penetrated the steel sheet, however, removal of the steel sheet revealed varying degrees of fire damage to the blue foam layer underneath.

Photograph 7: ‘Small flame’ test on complete panel.

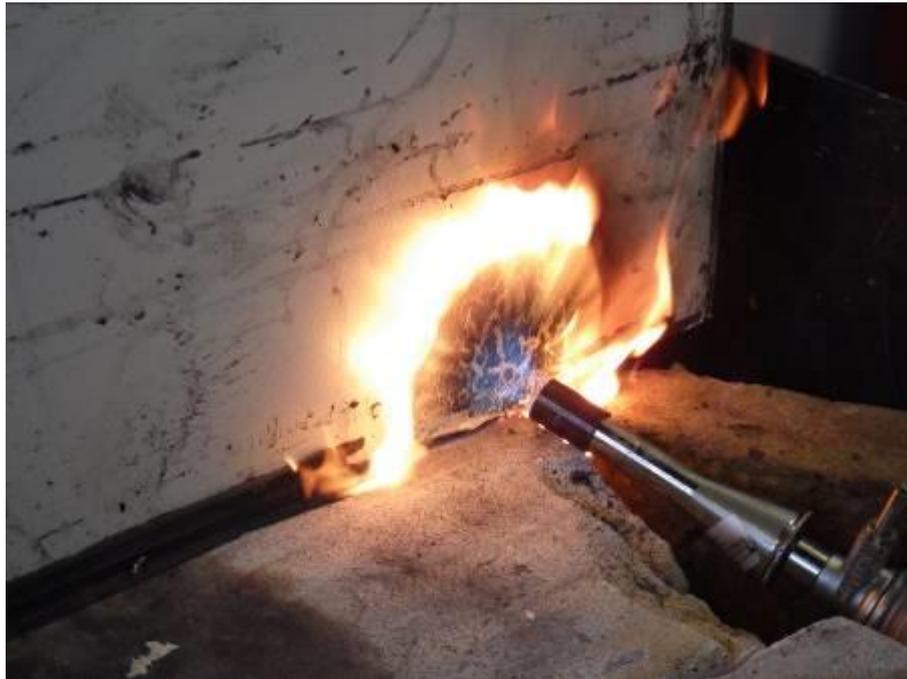
- 3.3 The flame tests all inflicted negligible fire damage to the metal surface of the complete panel. Removal of the external steel sheet showed that the blue foam layer underneath the steel sheet at the location of the flame tests had melted away. In the ‘Crib 6’ flame test, the blue foam had also been completely destroyed in some areas exposing the plywood underneath.

Photograph 8: ‘Large flame’ test on complete panel.

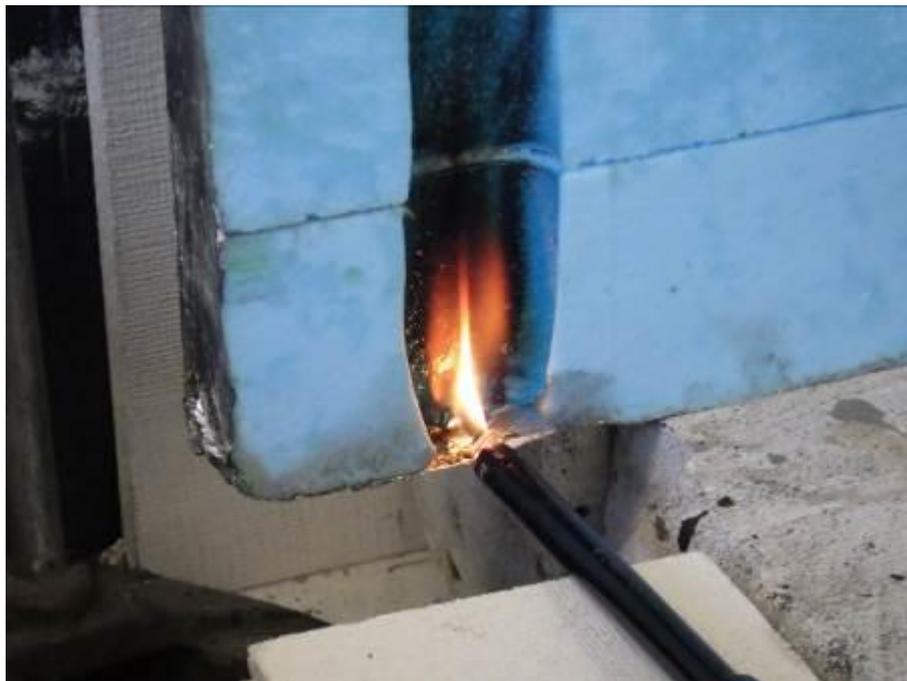
- 2.23 The repeat series of flame tests resulted in greater flame heights than the initial series of tests.
- 2.24 Flaming droplets were formed during the repeat flame tests that involved the blowtorch and the ‘Crib 6’ ignition sources.
- 2.25 There was sustained burning of the panel after the removal the ignition source during both the blowtorch and the ‘Crib 6’ repeat flame tests.
- 2.26 The repeat ‘Crib 6’ flame test was stopped due concerns over the flame height.

Photograph 11: Repeat of the 'Small flame' test against the blue foam layer.
